Manhole Inspection Summary

Manhole # S63M__009MH

Insp Date: **12/17/08 9:58 AM**

Location Address: **O'Donnell St.**

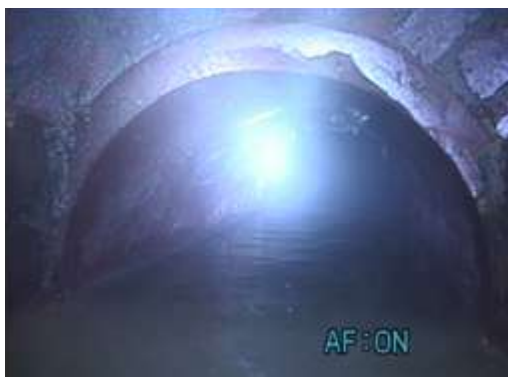
Defect 4

encrustation on I7

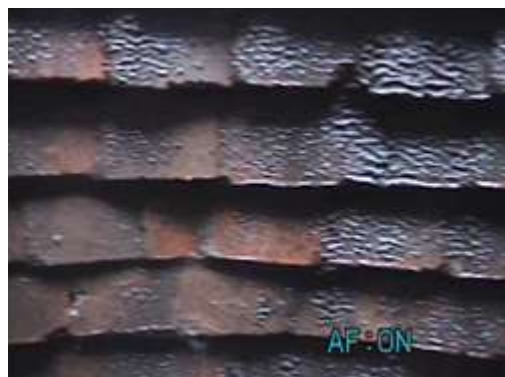
Defect 1

wall infiltration

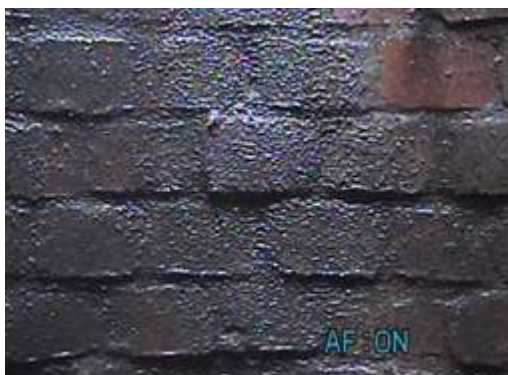
Defect 2

wall infiltration from mortar and joints

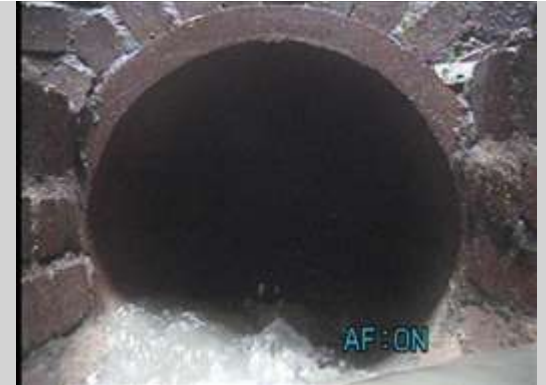
12 O'Clock Outflow

18 in. Circular Gravity Sewer
Pipe Out @ 12 O'Clock

Pipe Height: **18** (in.) Rod and Bar (Angled)
Pipe Material: **Clay** ☐ Pipe Lined
Invert Depth: **12.00** (ft.) Flow Characteristics: **Turbulent**
Deposits: ☒ None ☐ Mud ☐ Sludge ☐ Debris ☐ Grease
Silt Depth: (in.) Deposits Extent:
Infiltration: **None** Pipe Seal Cond: **Sound**

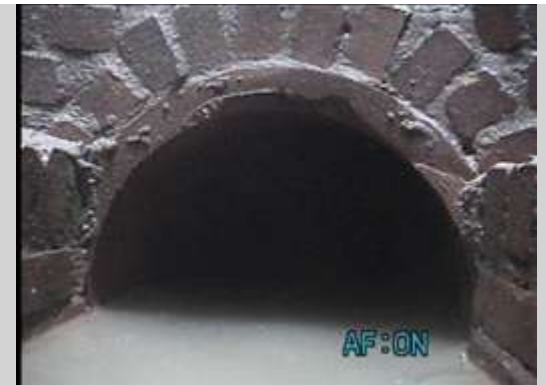
7 O'Clock Inflow

18 in. Circular Gravity Sewer
Pipe In @ 7 O'Clock

Pipe Height: **18** (in.) Rod and Bar (Angled)
Pipe Material: **Clay** ☐ Pipe Lined
Invert Depth: **11.88** (ft.) Flow Characteristics: **Fast**
Deposits: ☒ None ☐ Mud ☐ Sludge ☐ Debris ☐ Grease
Silt Depth: (in.) Deposits Extent:
Infiltration: **None** Pipe Seal Cond: **Sound**
